Missed Connection: Ballard Bridge Safety Recommendations

Connect Ballard,
a neighborhood affiliate of the
Cascade Bicycle Club

May 25, 2015

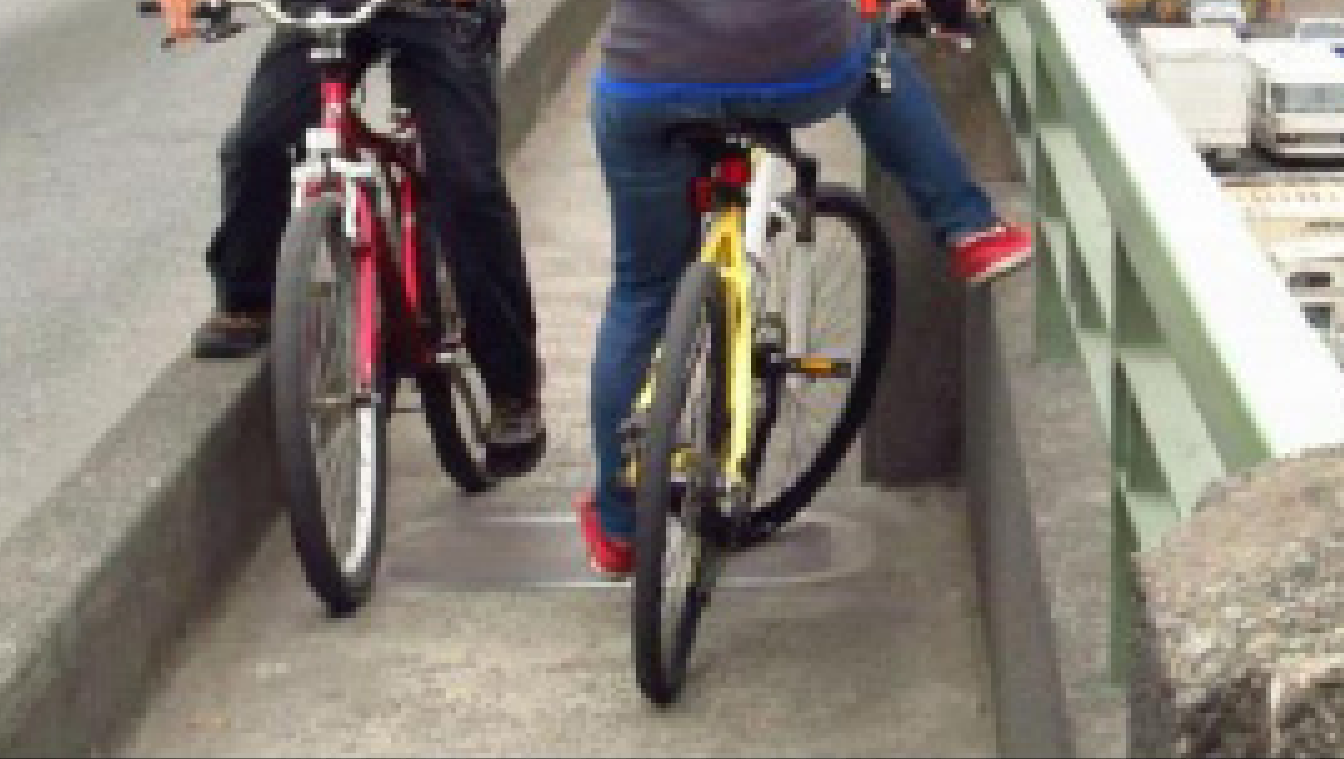
Width at Low Curb

1. Low Curb

The current curb height was established in construction documents from 1937 when the bridge was wood, cars were narrow and the speed of travel was much slower. In the 1950's, construction documents show concrete elements consistent with the original configuration, and it is what we still have today.

1. Improved safety rail

Changing the rail to a steel system will save weight and depth within the bridge section. It should have a traffic barrier sufficient to stop a vehicle without throwing chunks of concrete and railing into the sidewalk.

The rail should include an upper portion that does not represent a hazard to bicycle handlebars. The rail shouldn't impede into the sidewalk, and should cut back at a height to avoid handlebar conflicts while still meeting code requirements for safety from falls.

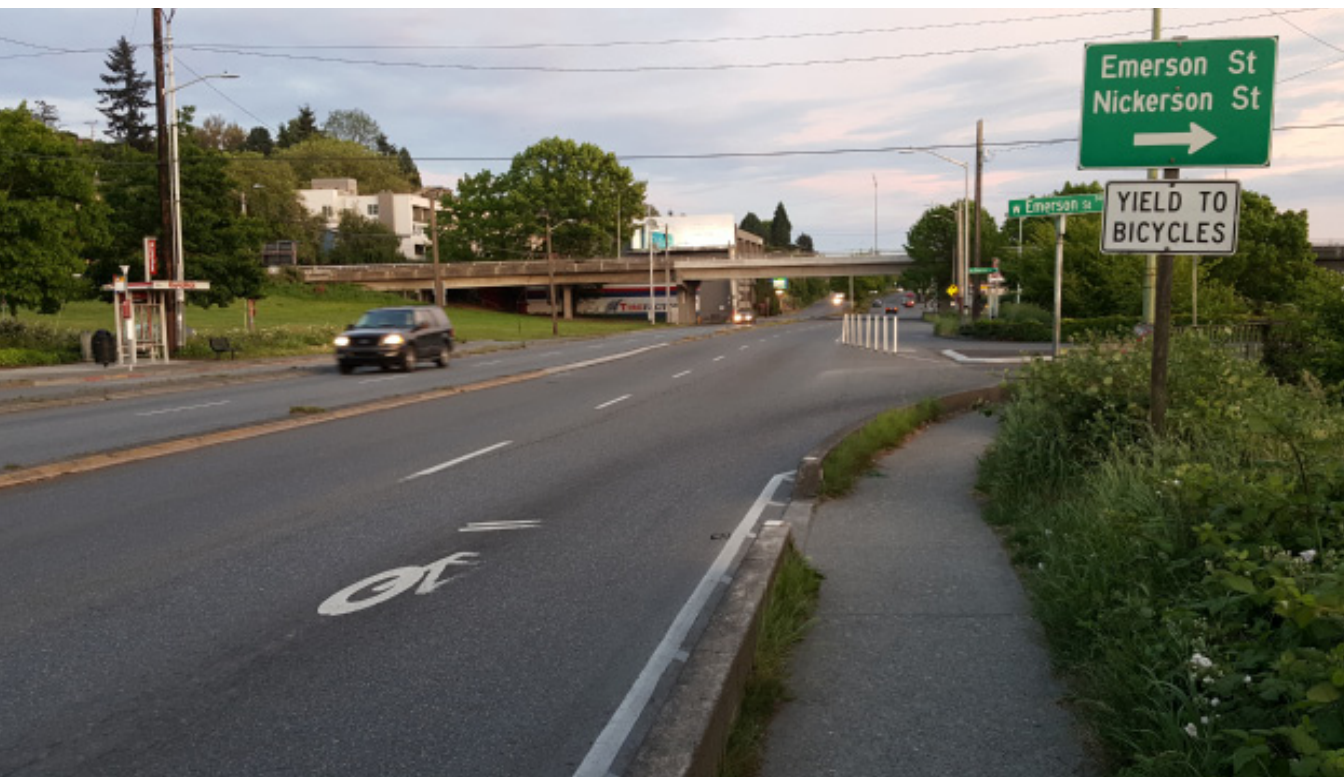
Southbound Merge

A. The southbound access from the bridge approach onto 15th Avenue is widely referred to as the Merge of Death. This consists of a narrow curb cut forcing bikes to enter the roadway nearly perpendicular to the flow of traffic, a variety of right turn exits and entrances, a bus stop and a right hand merge from a full stop in an area where traffic typically moves much faster than the posted speed limit. There is no viable option here for people walking, other than crossing under the bridge on a series of staircases.

3. South End Intersection

Revise the intersection where Emerson, Nickerson and 15th Avenue converge and restore it to a street grid condition, similar to the traffic light at the south end of the Fremont Bridge. Address the northbound and southbound bridge approaches, from the Dravus Street overpass all the way to the bridge sidewalk.

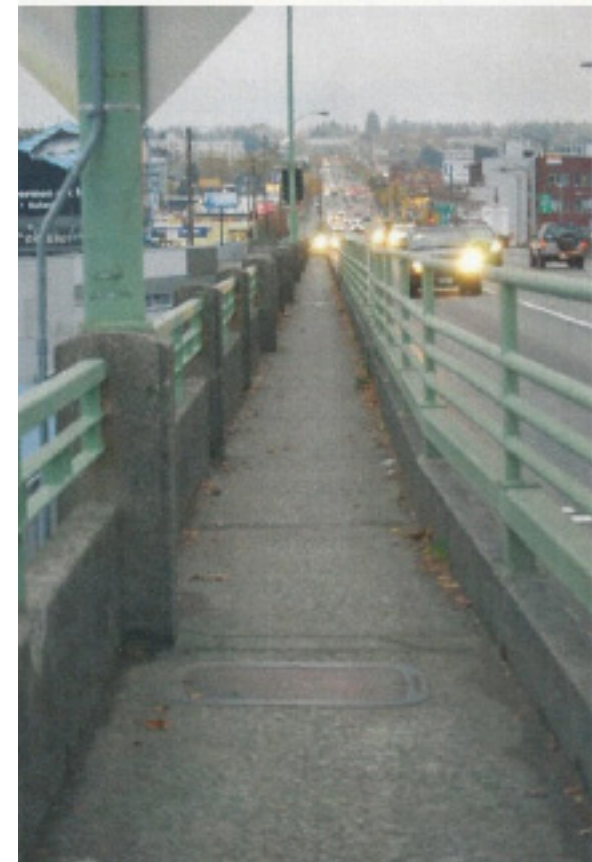
Width at Railing

2. Narrow Sidewalk

The outer dimension of the bridge hasn't changed since it was built, but the materials have. The narrowest dimension at the largest outside rail posts is 3'-5". Standard bike handlebars with a basic side mirror can be almost 3' wide. This doesn't allow a margin of safety for pedestrians, bikes and strollers when people meet or have to pass, or when bikes need to negotiate a crumbling and poorly draining sidewalk crossed by metal expansion joints.

2. Widened sidewalk

For immediate needs, move the inner rail one foot closer in, making the traffic lanes approximately 10' wide, while gaining space for a steel rail guard that is narrower than the existing concrete.

Removing the outer concrete rail will provide another 18" inches to the sidewalk if a new steel railing is mounted to the face of the bridge structure. Combined, these modifications will provide a sidewalk width of more than 5'-6".

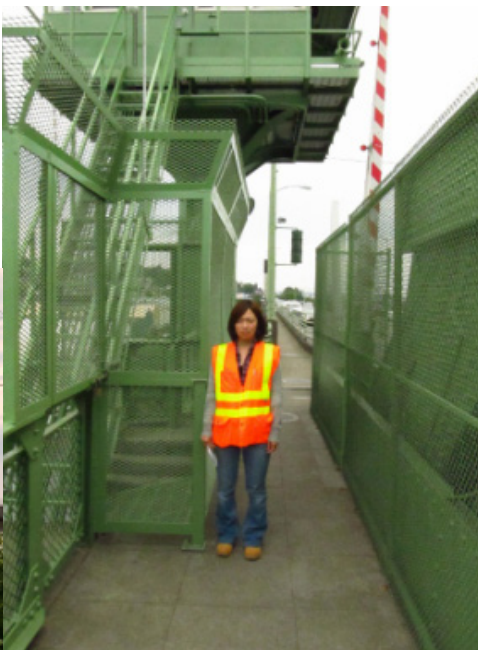
Width at Maintenance Area

The bridge has several issues related to maintenance. The tightest points along the route for people walking and biking are the metal cages around the service stairs to the underside of the bridge. On one side there is a protective barrier for the bascule mechanism, but on the other side the permanent cage is around a stair that is used occasionally.

To alleviate the current constriction at maintenance access points to the lower portions of the bridge, provide hatches and temporary safety rails for use when those areas require access.

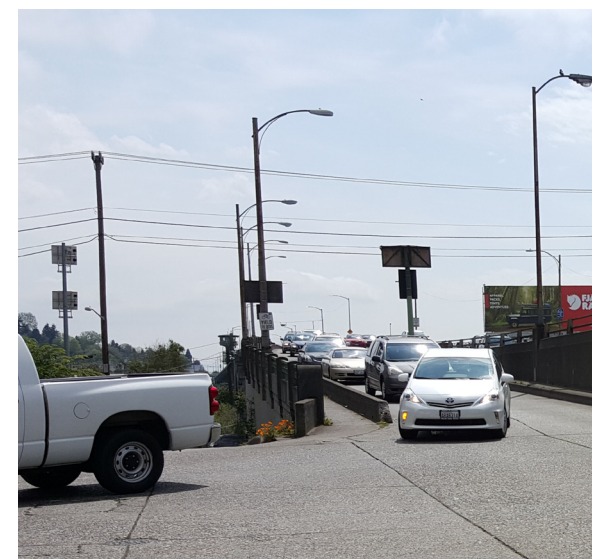
Northbound End of Sidewalk at North

The entire system lacks connections, running tantalizingly close to the South Ship Canal Trail without actually offering a viable way to close the gap. The north end comes close to the Burke Gilman Trail, but between the Missing Link and the absence of any intended route, there are no clear options to enter or leave the bridge. There is no safe connection to the bicycle facilities along the waterfront, from the Terminal 91 Bike Path through Myrtle Edwards Park.

4. North End Approaches and Exits

Excess lane width at entry and exit ramps can be used to create adequate sidewalk widths along the east and west sidewalks. This will also create a traffic calming effect on the on and off ramps.

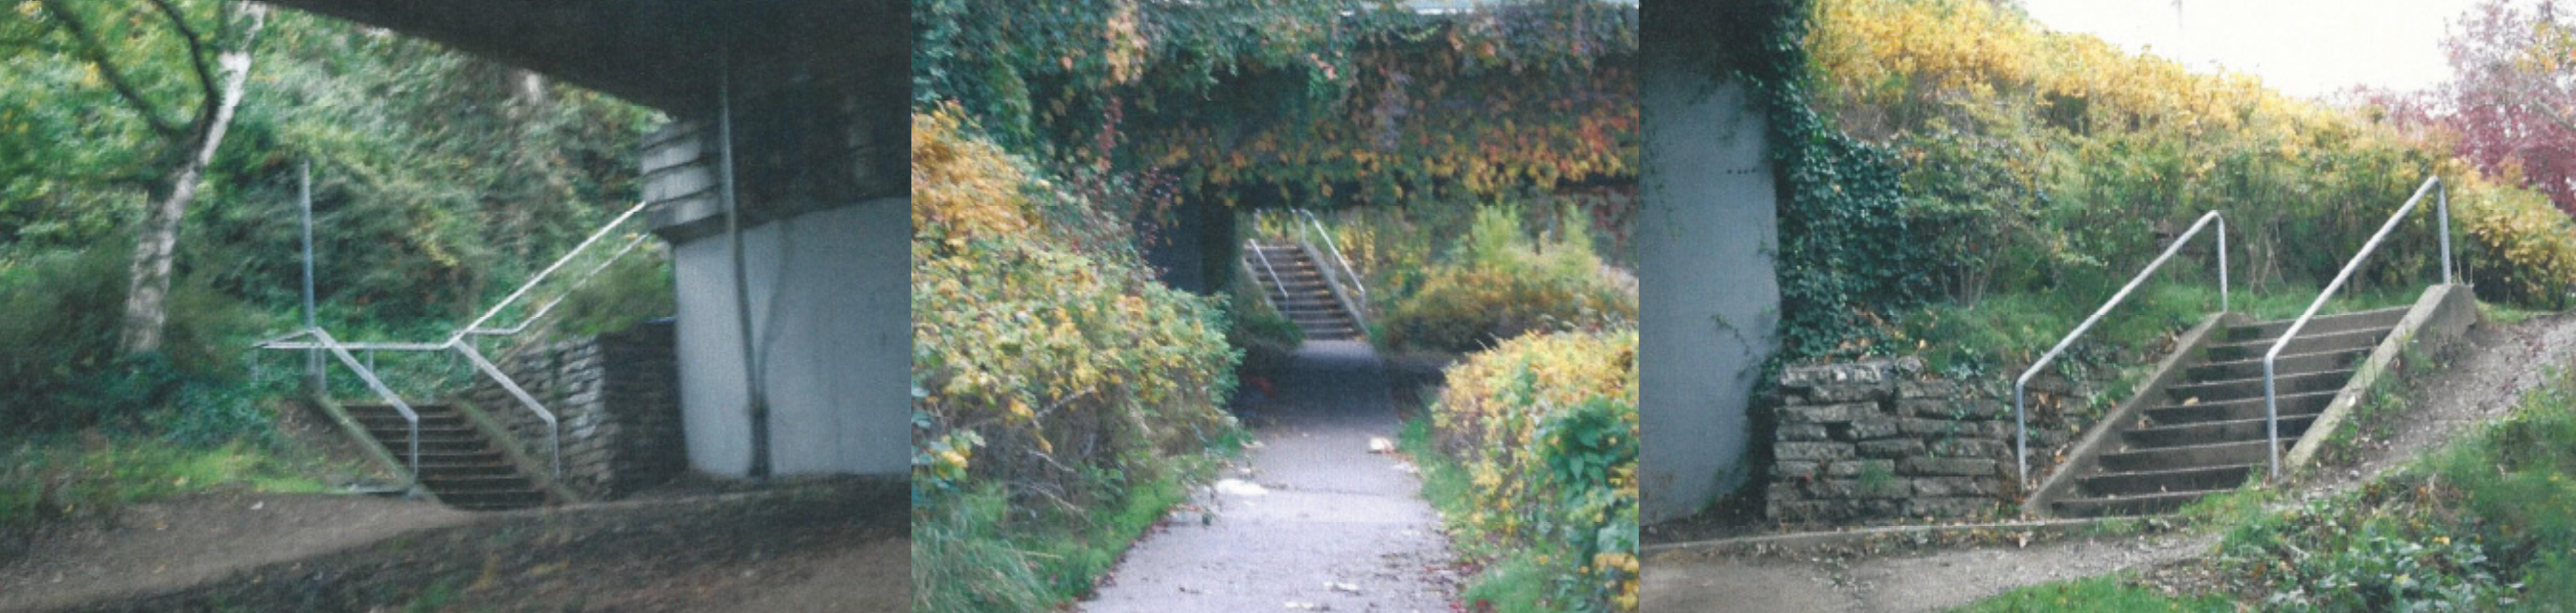
South Path from East to West under
15th from Emerson to Nickerson

B. The approach northbound from the south isn't much better, requiring the crossing of traffic exiting 15th Avenue to Nickerson and Emerson, a bus stop, and traffic entering the bridge through a complex merge from the east. People walking are forced through a circuitous series of crossings to access the bus stop and the bridge.

Extend the South Ship Canal Trail to connect to 15th Avenue, and to a future reconfigured connection that also accesses the future 16th Avenue Greenway called out in the Bicycle Master Plan.

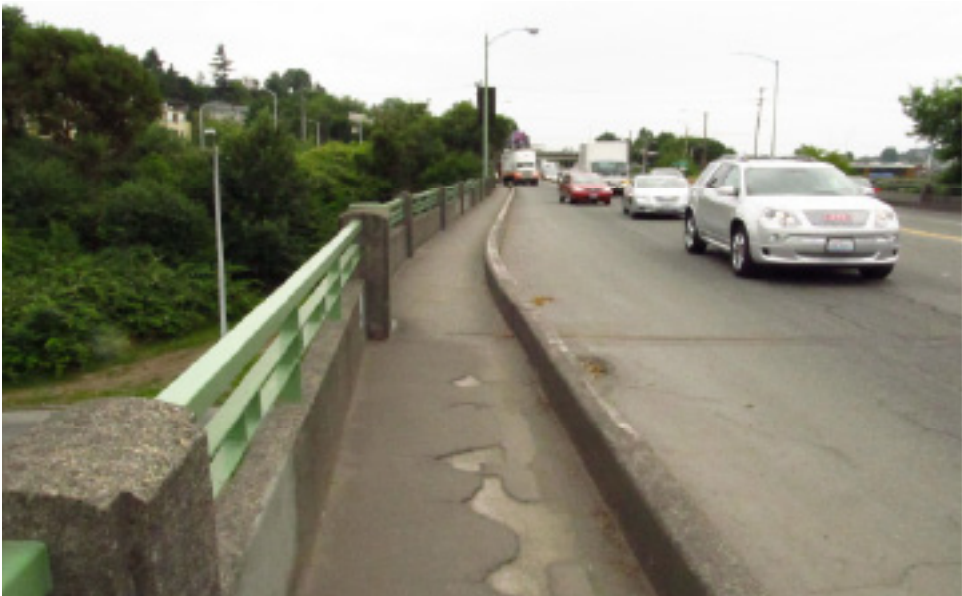
Southerly View of East Sidewalk
Photo: SDOT Sidewalk Widening Alternative Study

The other issue has to do with the maintenance of the actual sidewalk area. In addition to the broken surface of the walkway, it is crossed by metal expansion joints which are often not visible, either due to puddles or darkness.

Provide small drains to eliminate puddles, especially on the eastern sidewalk. These should be in the form of drainage holes, not grated drainage, to avoid creating hazards for sidewalk users.

Repave or improve the current patching and paving conditions along the full length of the bridge. The previous attempts have not properly prepared the sidewalk and haven't held up to the light sidewalk traffic.
