Missed Connection: Ballard Bridge Safety Recommendations

Connect Ballard,
a neighborhood affiliate of the
Cascade Bicycle Club

May 25, 2015

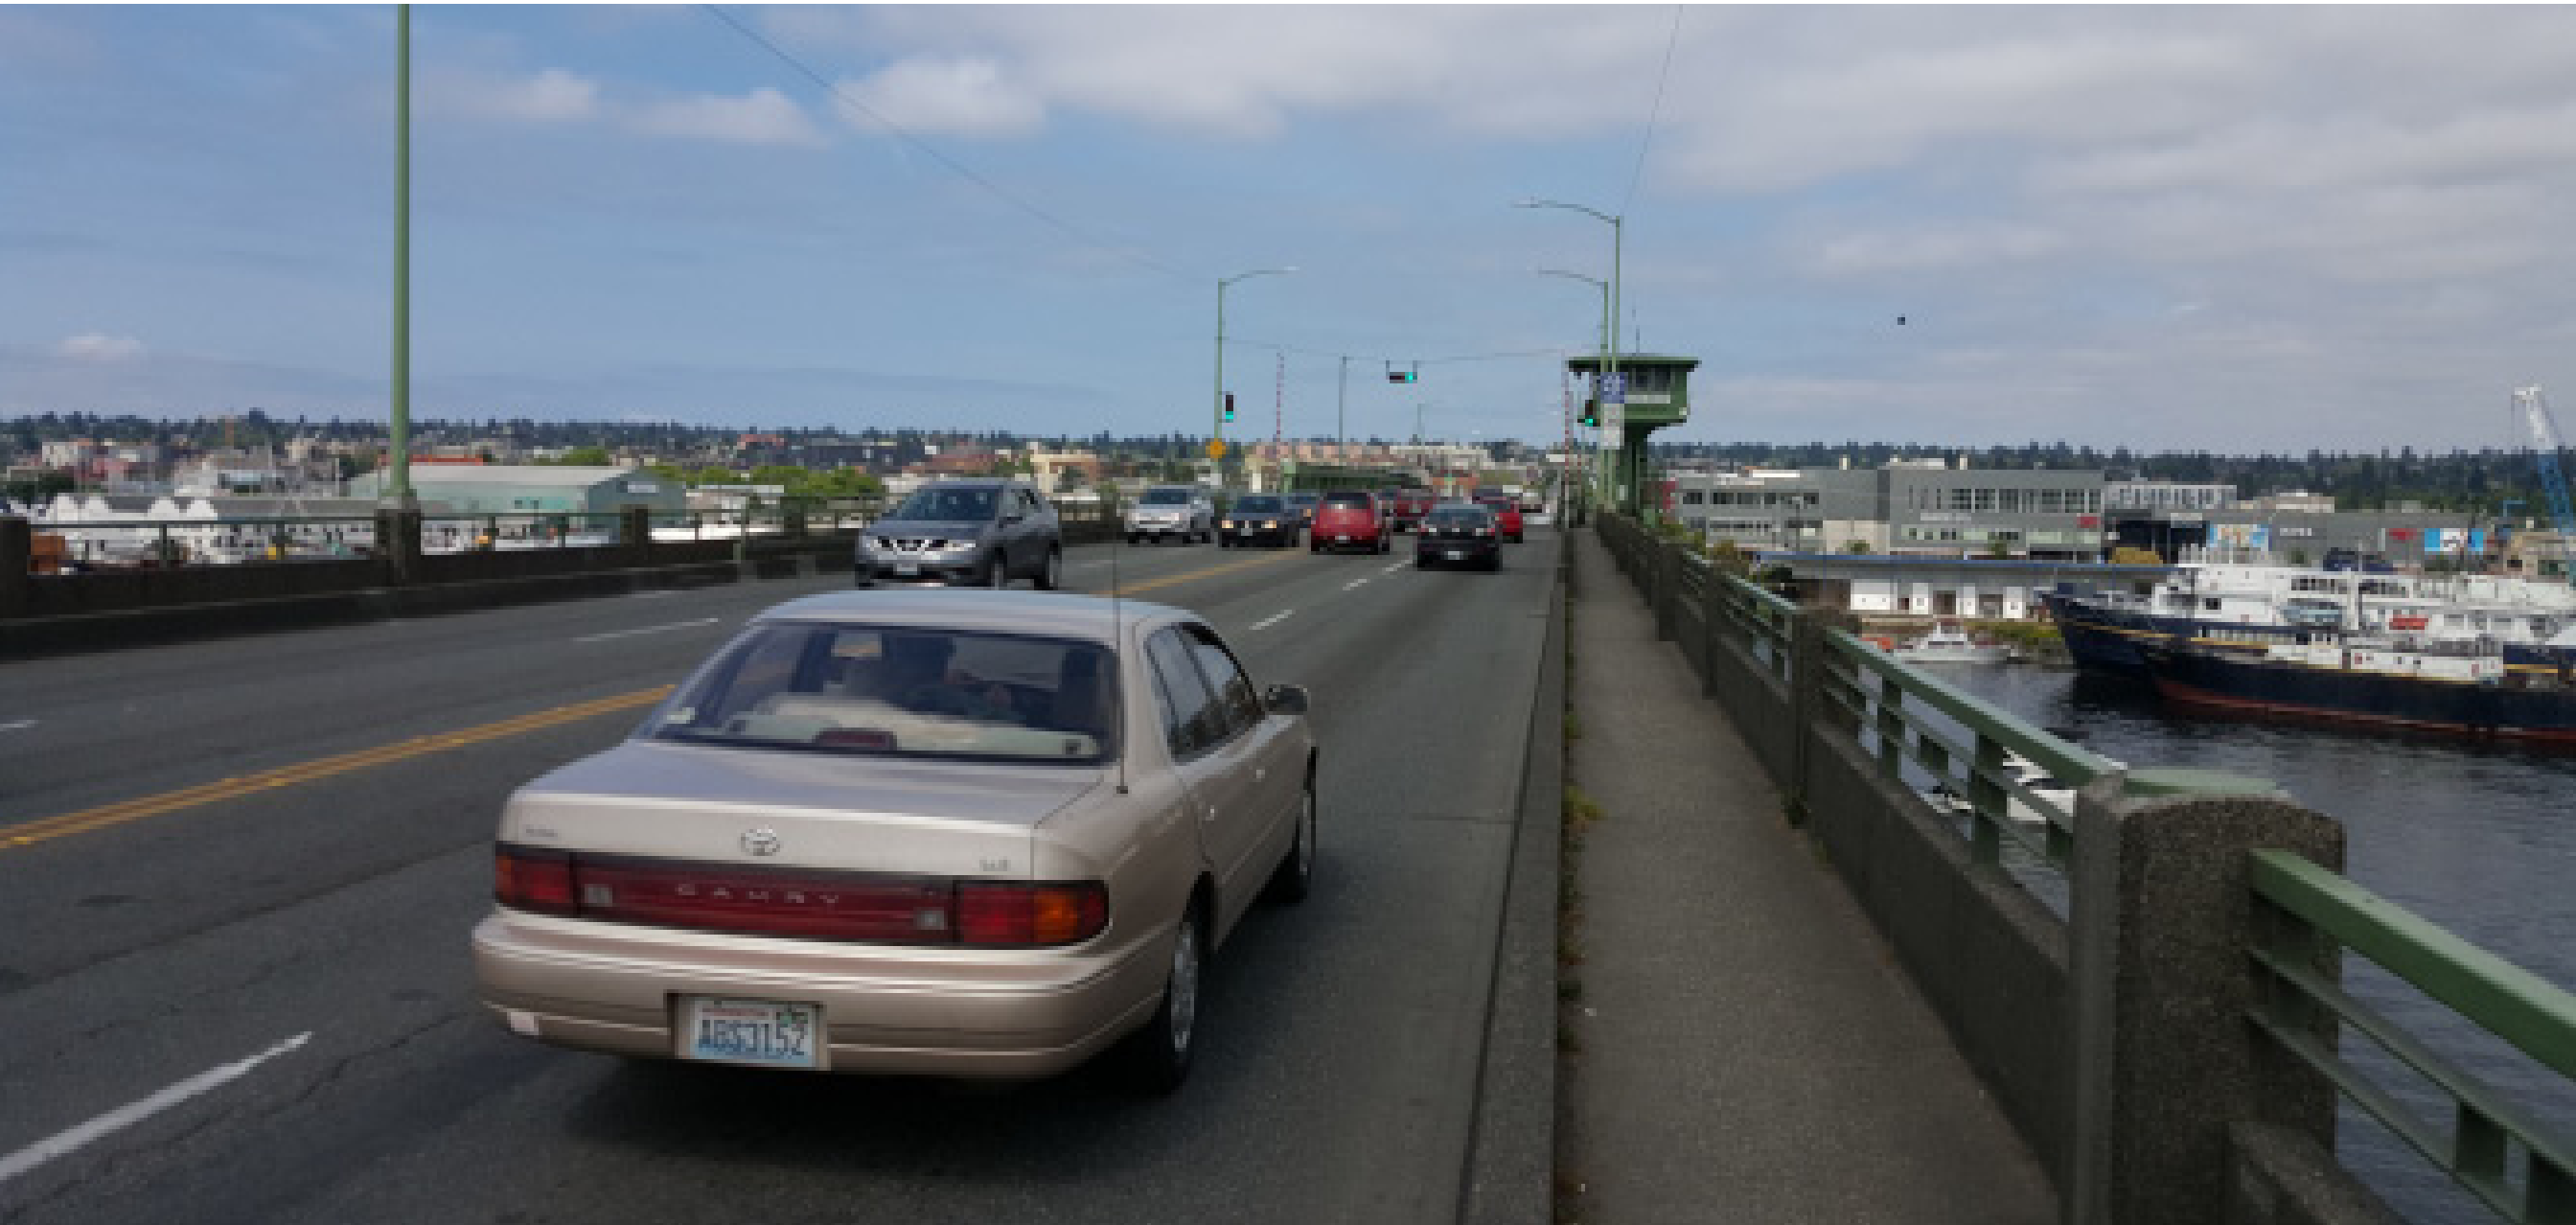
2. Narrow Sidewalk

The outer dimension of the bridge hasn't changed since it was built, but the materials have. The narrowest dimension at the largest outside rail posts is 3'-5". Standard bike handlebars with a basic side mirror can be almost 3' wide. This doesn't allow a margin of safety for pedestrians, bikes and strollers when people meet or have to pass, or when bikes need to negotiate a crumbling and poorly draining sidewalk crossed by metal expansion joints.

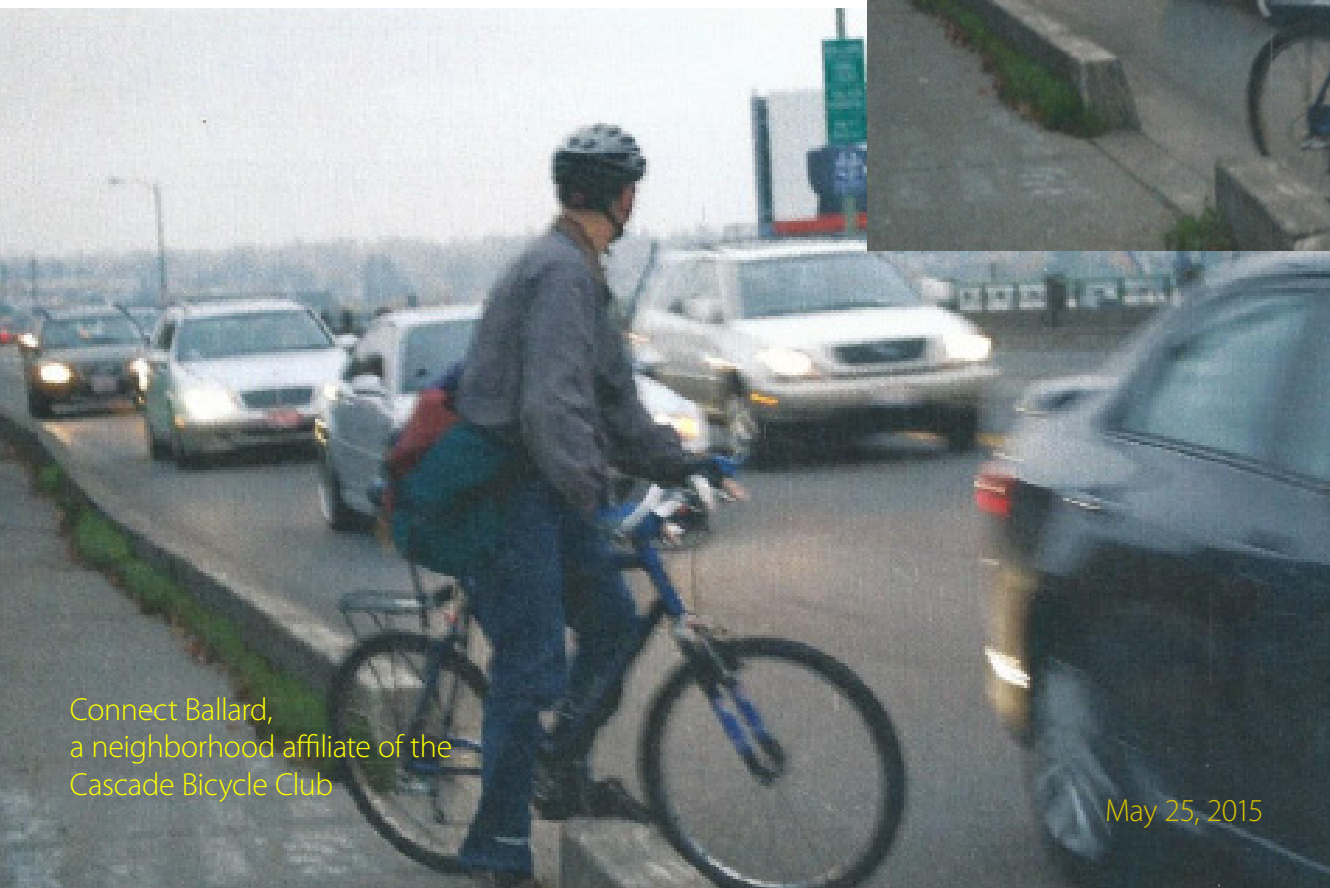
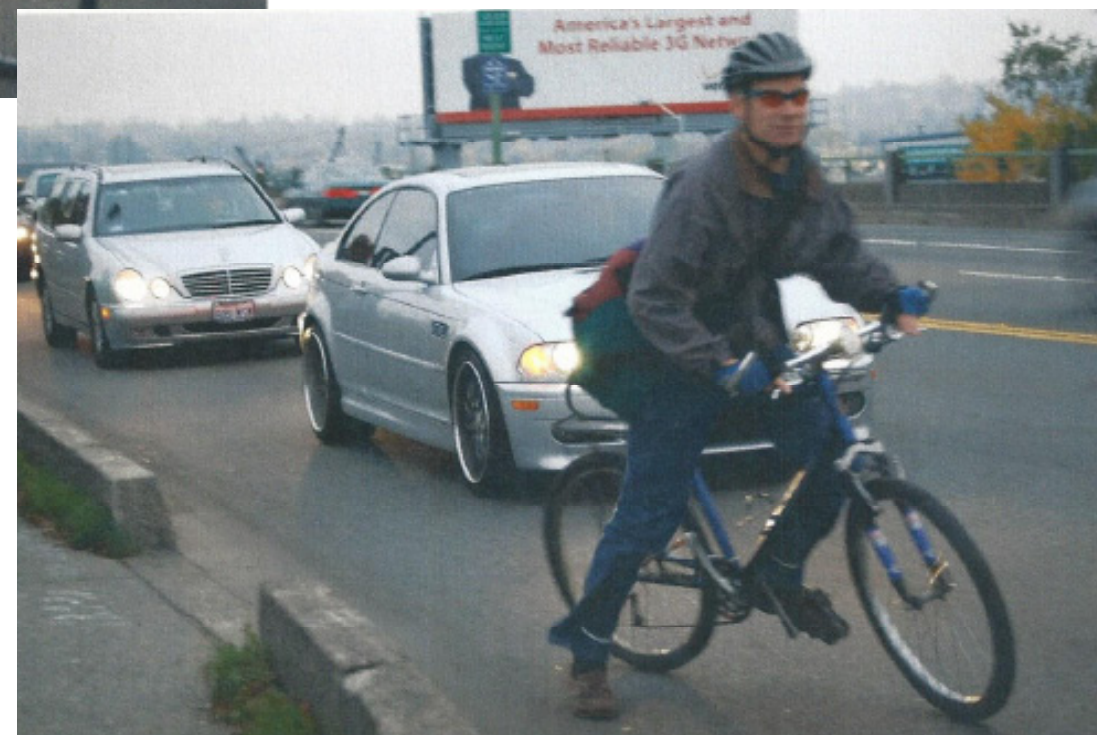
Southbound Merge
Photos: Sean Cryan

A. The southbound access from the bridge approach onto 15th Avenue is widely referred to as the Merge of Death. This consists of a narrow curb cut forcing bikes to enter the roadway nearly perpendicular to the flow of traffic, a variety of right turn exits and entrances, a bus stop and a right hand merge from a full stop in an area where traffic typically moves much faster than the posted speed limit. There is no viable option here for people walking, other than crossing under the bridge on a series of staircases.

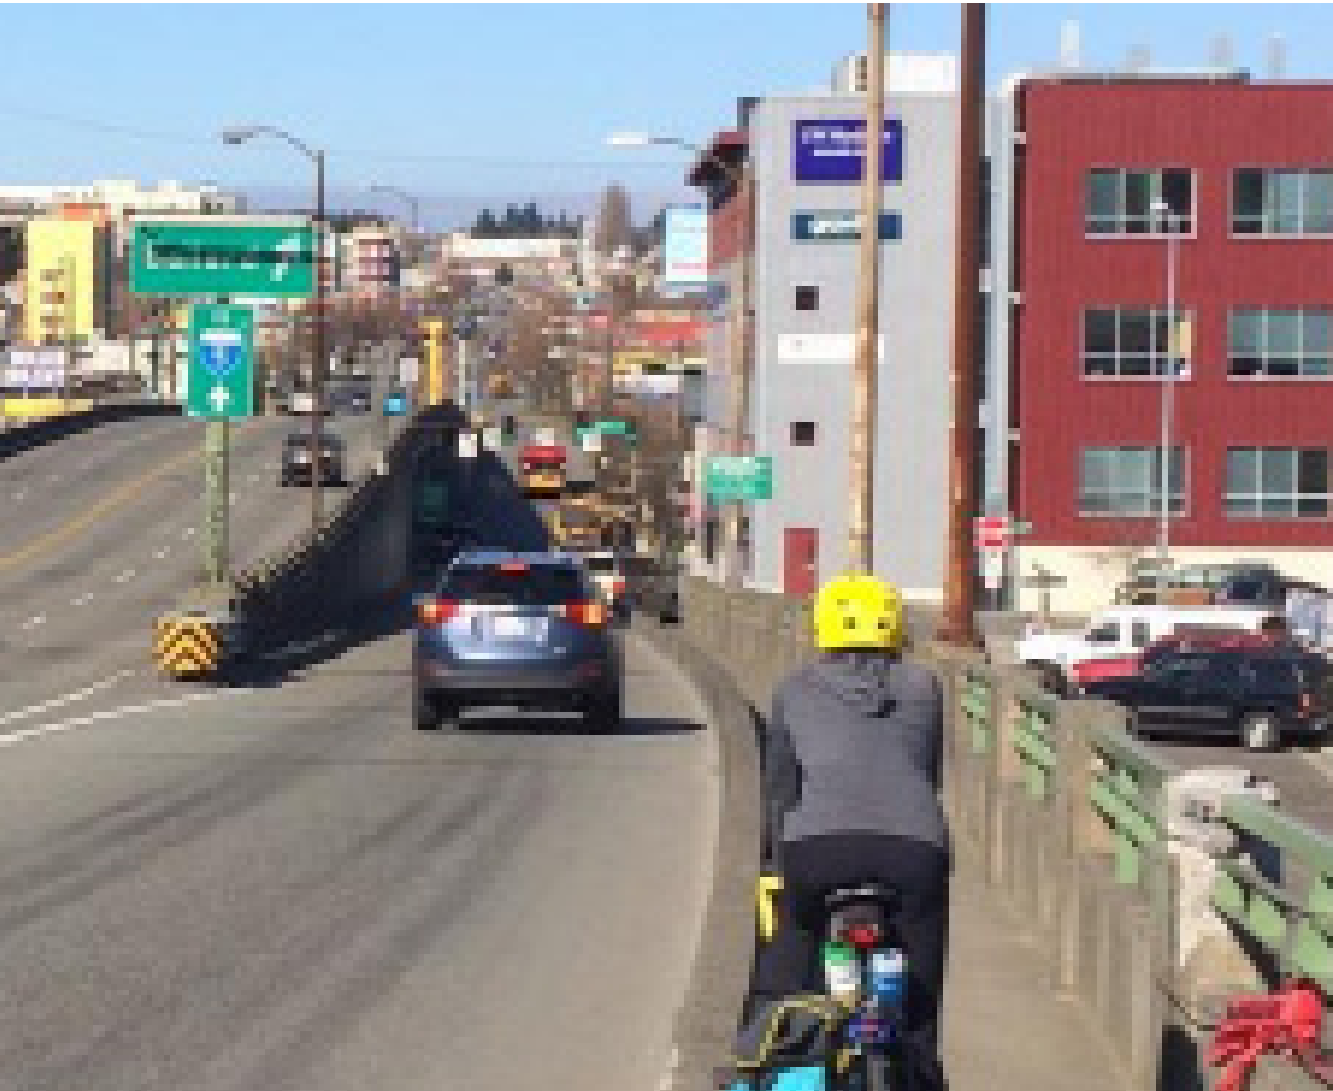
**Northbound Bridge Exit
with Extra Space for Sidewalk Widening**

The available space along the bridge approaches and the entry ramps should be studied for possible adjustment to achieve additional width for the sidewalk.

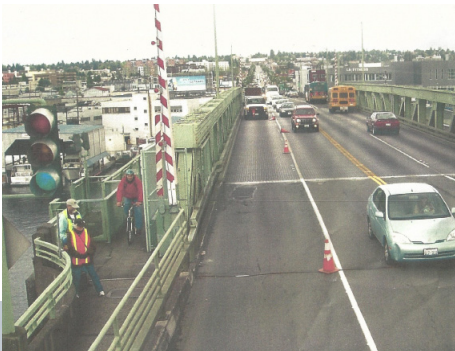
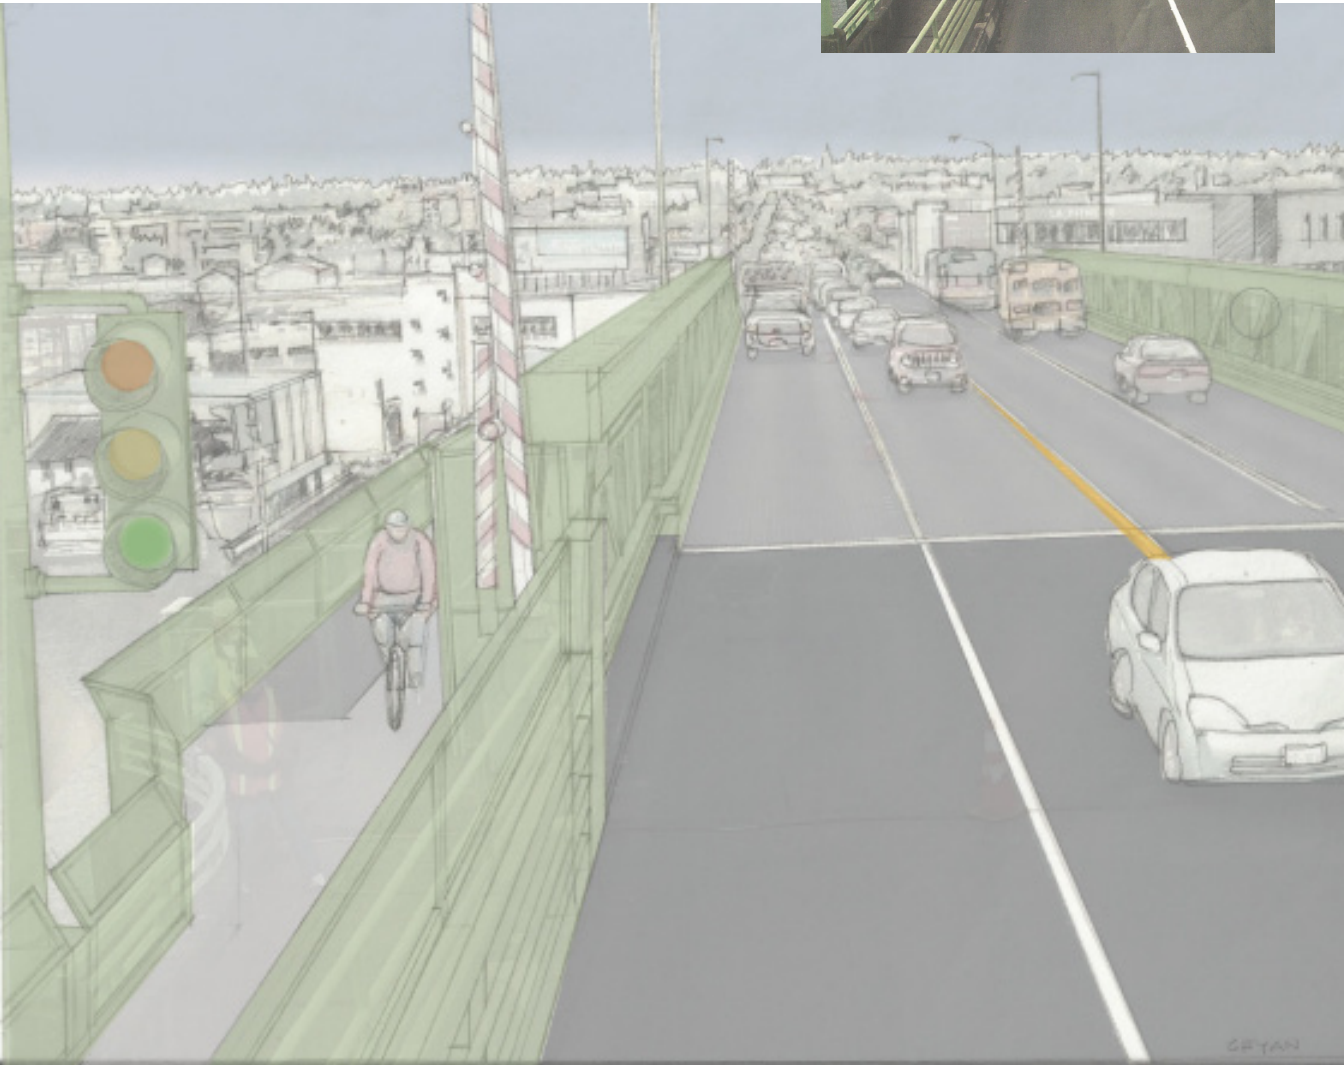
Bascule Bridge Maintenance Access
Photo: SDOT
Rendering: Sean Cryan

The bridge has several issues related to maintenance. The tightest points along the route for people walking and biking are the metal cages around the service stairs to the underside of the bridge. On one side there is a protective barrier for the bascule mechanism, but on the other side the permanent cage is around a stair that is used occasionally.

To alleviate the current constriction at maintenance access points to the lower portions of the bridge, provide hatches and temporary safety rails for use when those areas require access.
